Redesigning Stopes for Improved Recovery of Ore

Project Summary

\$1 MILLION OF UNRECOVERABLE ORE

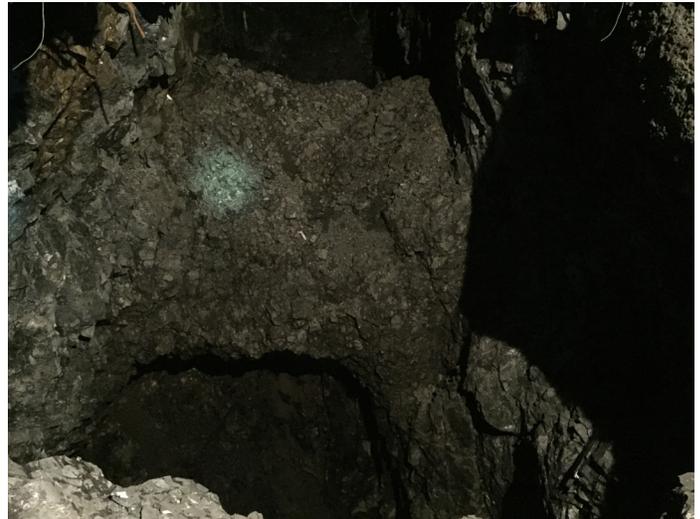
Although the customer had initially assumed the issues they were experiencing could be resolved with different delay times, the investigation on site quickly revealed that the issue was related to lack of relief for the stope blasts.

The void into which the rock from the stopes was designed to expand was far too little to allow for proper rock breakage. DynoConsult's representative informed the

mining engineers at that time that most, if not all, of their blasting issues could be resolved by redesigning their stope panels to incorporate a greater void for relief.

After the investigation, the DynoConsult representative sat down with the mining engineers and worked out a new stope development plan that would produce the proper amount of void in the panel for proper rock expansion.
